## Accessibility Audit Report

# Birtley House Independent School

Fawkham Road  
West Kingsdown  
Sevenoaks  
TN15 6AY

Access Consultant: S Malton  
Date: 30<sup>th</sup> October 2025

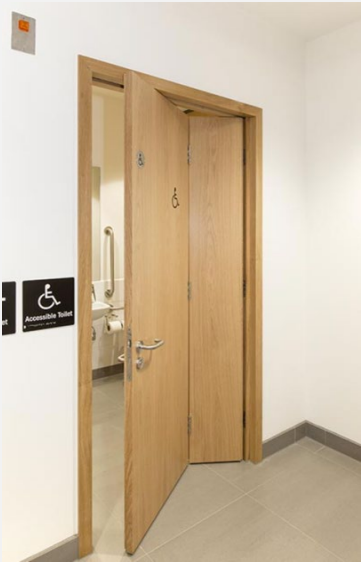
| 13.3 | <p>The compartment door within the mobile building facility has been altered to open outwards, as recommended during the previous audit.</p> <p>The compartment door for the facility within the main building opens inwards. This may be deemed reasonable to retain.</p> | <p>Preferably, doors should open outwards on accessible WC facilities. Where this is not possible, as further routes may be obstructed, compartments doors should be fitted with emergency release mechanism so that they are capable of being opened outwards, from the outside, in case of an emergency.</p> <p>Alternatively, bi-folding doors could be used on the accessible WC facilities identified.</p> | M |

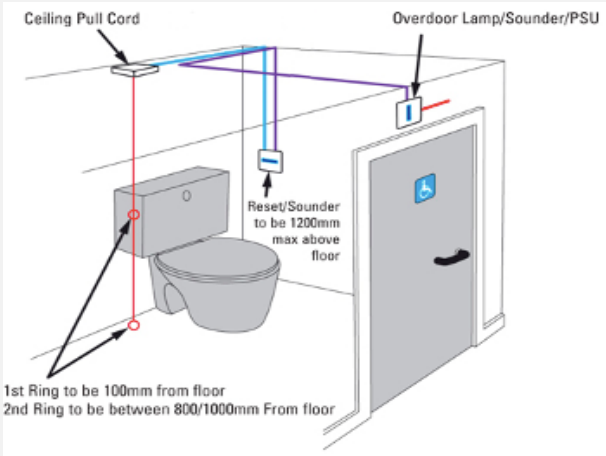
| 13.11 | <p>The cord alarm provided to the facility in the main building was positioned behind a sanitary disposal bin. This could prevent it from being accessed during the event of an emergency.</p> | <p>Implement a management procedure to ensure that cord alarms are always kept loose and not obstructed.</p> <p>According to BS8300 - An emergency assistance pull cord should be sited so that it can be operated from the WC and from an adjacent floor area. The emergency assistance pull cord, coloured red, should be provided with two red bangles of 50 mm diameter, one set at a height between 800 mm and 1000 mm and the other set at 100 mm above floor level.</p> | N |

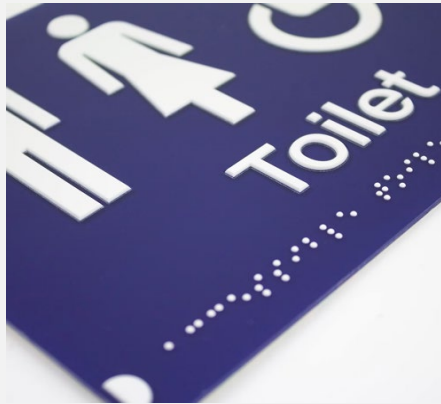
| 15.3 | <p>Signage with pictorial information has been provided to most WC facilities, other than the first facility on the first floor.</p> <p>No signs, including those on the accessible WC facilities, were identified as feature tactile or braille information.</p> | <p>Consider the provision of accessible WC signage that incorporates braille and tactile information.</p> | M |

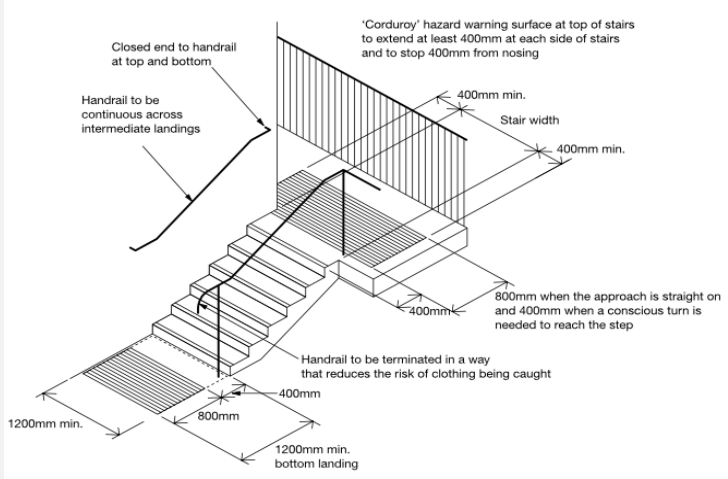
| Priority 4 | | | |
|---|---|---|---|
| 4.1 | <p>Tactile warnings have not been provided to the larger flight of steps leading towards the playing field.</p> | <p>People who are blind or partially sighted risk tripping or losing their balance if unaware of steps, requiring the provision of tactile paving. Tactile paving needs to be placed sufficiently in advance at the head and foot of the steps to allow time to stop and not so narrow that it might be missed in a single stride.</p> <p>Proportionate to demand, install tactile paving to the external steps identified.</p> <p>BS8300 - To give advance warning of a step, tactile paving with a corduroy hazard warning surface should be provided at the top and bottom of each flight, excluding intermediate landings with continuous handrails. Where the approach to the stair is wider than the flight, the tactile surface should extend beyond the line of each edge of the flight.</p> | M |
