## Accessibility Audit Report

# Birtley House Independent School

Fawkham Road  
West Kingsdown  
Sevenoaks  
TN15 6AY

Access Consultant: S Malton  
Date: 30<sup>th</sup> October 2025

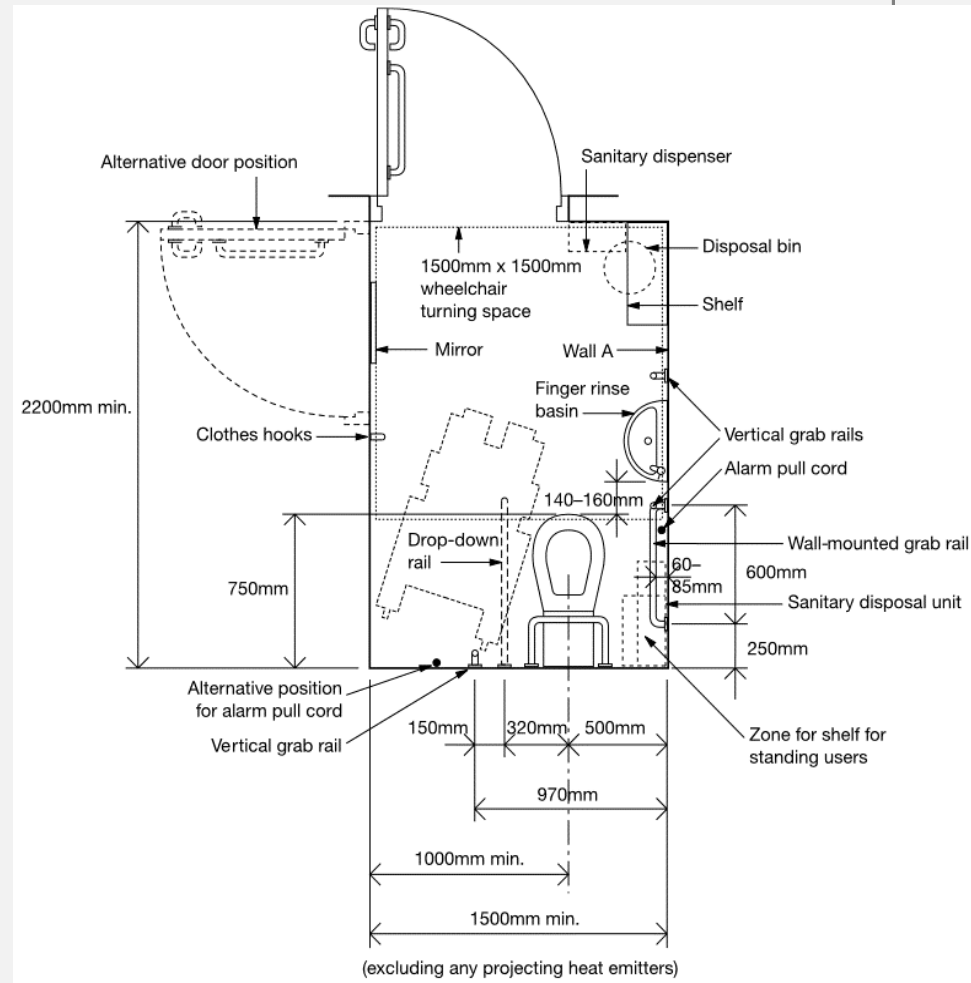
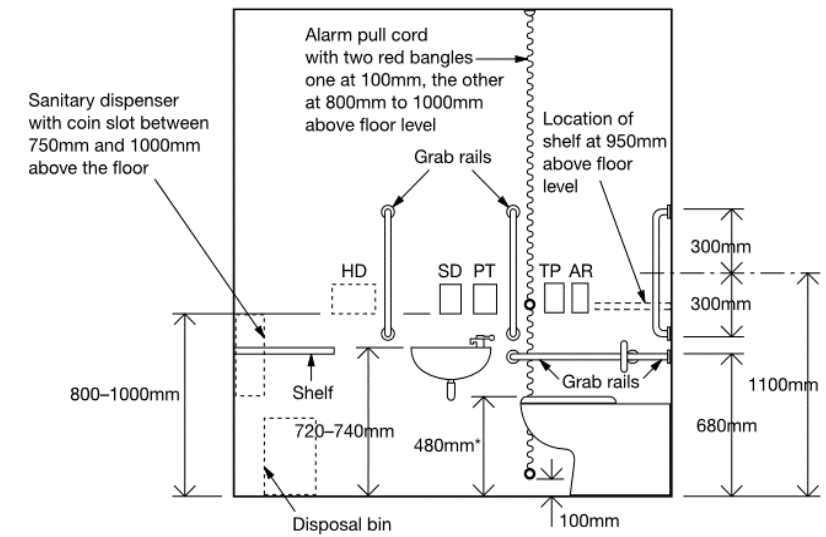
13.1

| | <p>The accessible WC facilities were measured as follows:<br/>Mobile building: 3001mm by 1393mm<br/>Main building: 3628mm by 1771mm</p> <p>The toilet pan remains centrally located within the mobile building compartment.</p> | <p>As per previous reports, this is deemed reasonable to retain if people are aware of the alternative WC facility within the main building and if level access to this facility is provided.</p> <p>Should a member of staff or student have a specific requirement, the layout should be reviewed and altered to achieve the correct Part M positioning to allow a side wheelchair transfer.</p> | |

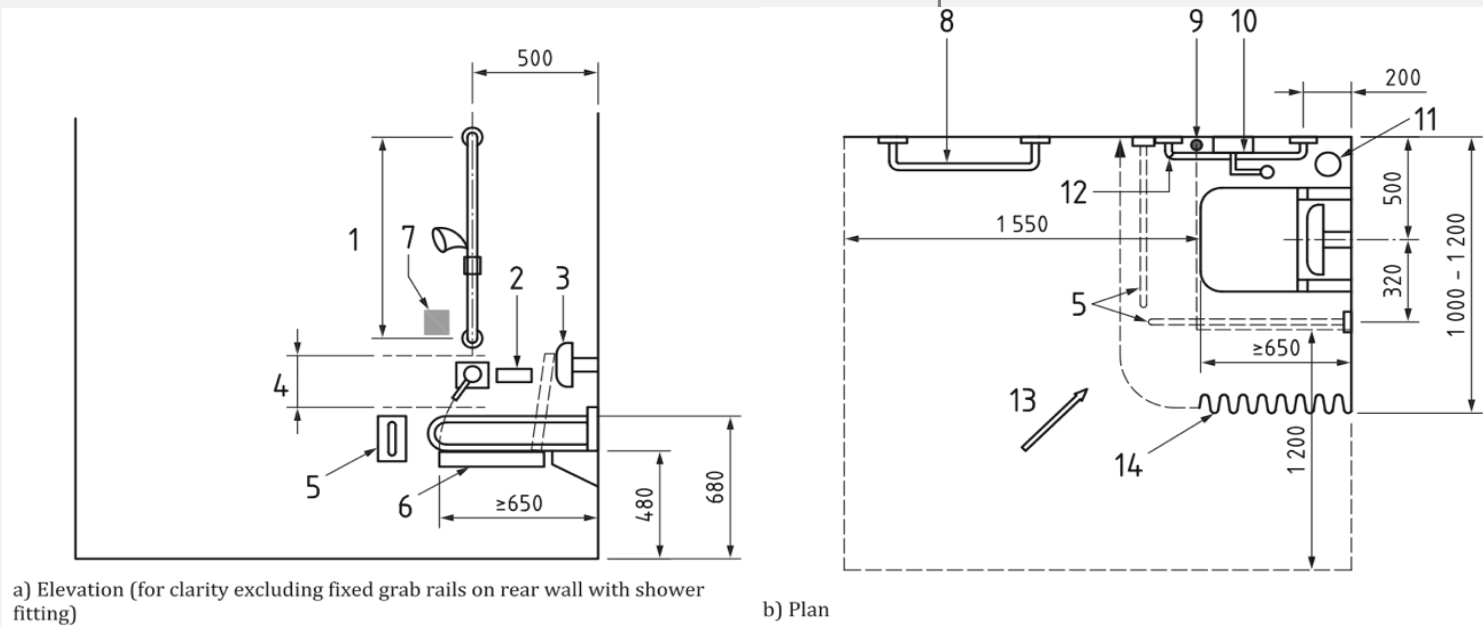
12.8

| | <p>A level access shower remains available in the Rabbit classroom building; however, the raised threshold to contain water could be a barrier for wheelchair users. The controls for this shower are high from ffl.</p> <p>The shower facility on the first floor remains decommissioned since the previous audit.</p> | <p>Proportionate to demand, and should level access be gained into the building where the shower facility is situated, it is recommended to refurbish the shower facility to be accessible for all potential users.</p> <p>BS8300 to be referred to for the layout.</p> | |

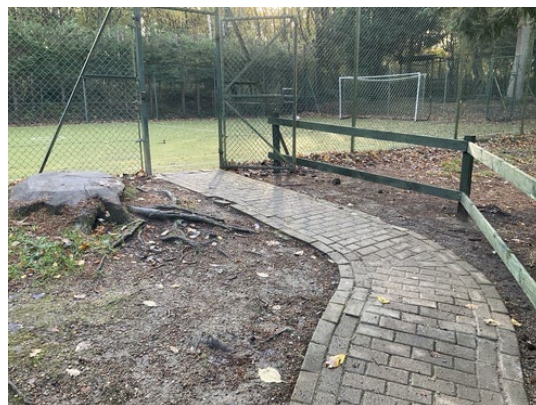
Photo 4

The top of the paving towards the sports courts is lifting in some areas, which could be trip hazards.

There is a crack developing next to the main entrance and accessible parking bay, which could develop further into a trip hazard.

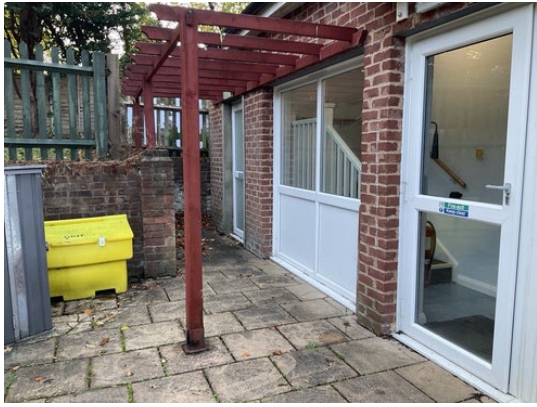
Photo 7

As identified in the previous audit, one wooden column is located near to the conservatory. This column does not feature a contrasted band that could assist with reducing a collision hazard.

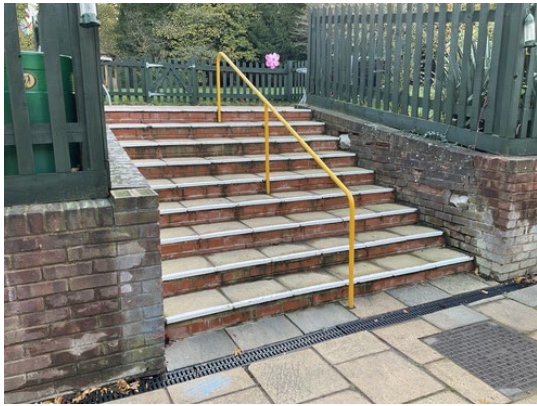
Photo 32

A handrail is available to the centre of the steps leading towards the field and has been provided with good contrast, as recommended during the previous audit.

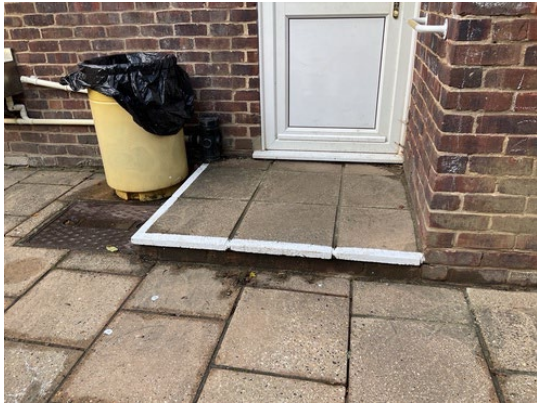
Photo 38

The two steps leading into the main entrance may benefit from remarking, as the paint is worn in some areas.

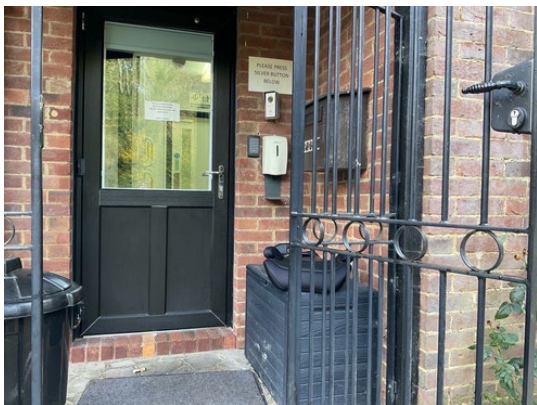
Photo 50

The lever door handle had been replaced since the previous audit, providing contrast both externally and internally.

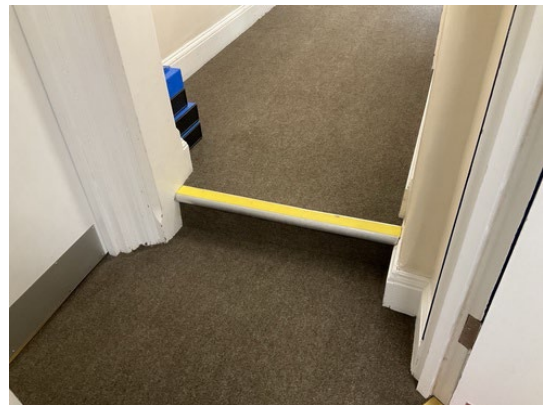
Photo 65

No internal columns were identified. The angled ceiling on the first floor of the main building has been highlighted to assist with reducing a collision hazard. Although single steps are not recommended, it may not be feasible to remove them from site. They have, however, been well highlighted.

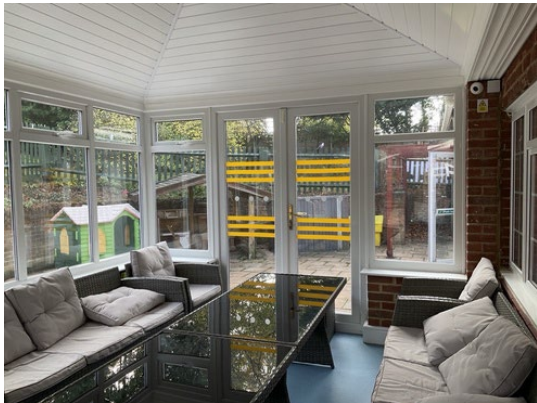
Photo 72

Brightly contrasted manifestations have been applied to the doors of the conservatory, as per the previous audit's recommendation.

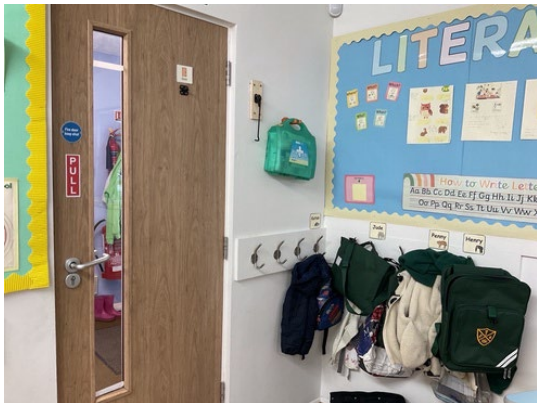
Photo 74

The doors within the mobile building have been replaced since the previous audit with those featuring compliant vision panels.

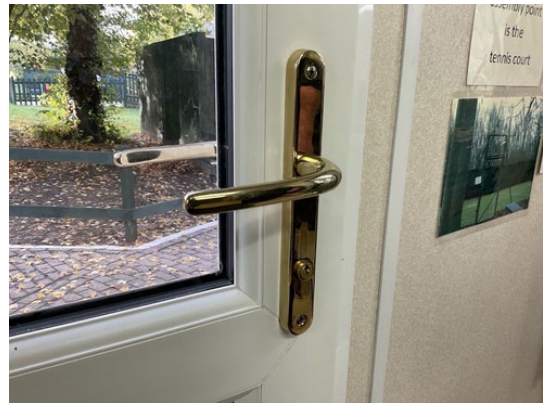
Photo 75

Lever door handles across the school have been replaced with alternatives that provide a good level of contrast, as suggested in the previous audit.

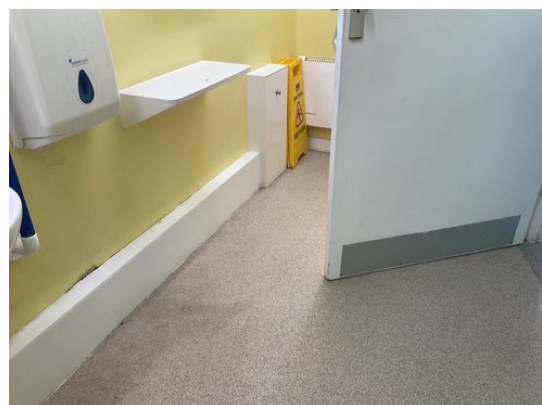
Photo 101

The compartment door within the mobile building facility has been altered to open outwards, as recommended during the previous audit.

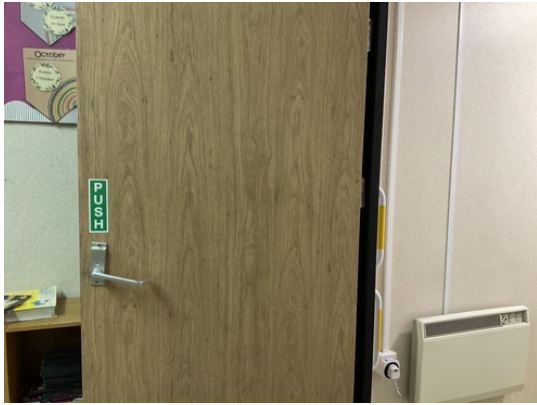
Photo 102

A horizontal grab rail is missing from the facility door in the mobile building.

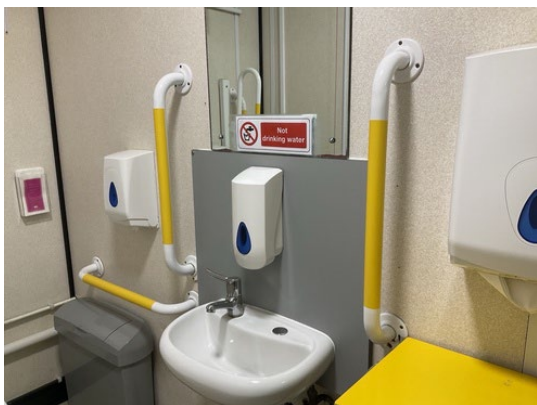
Photo 108

The grab rail set within the mobile compartment have been replaced with those that provide greater contrast, as recommended.
